**King County  
International Airport**

RE: Northeast T-Hangars – Contaminated Soils

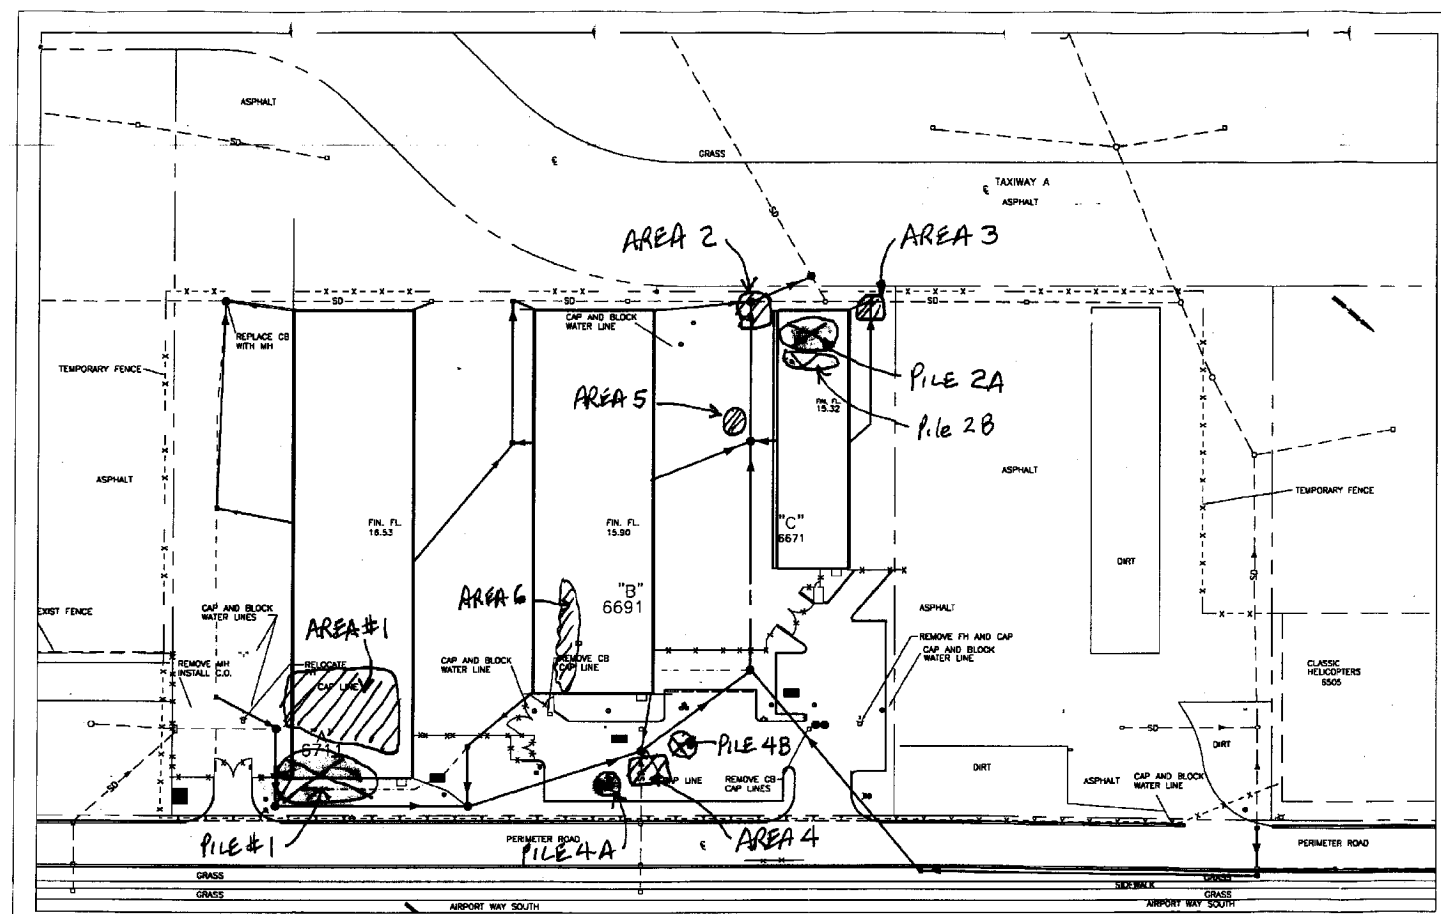
- 8-13-99 Contractor noticed some petroleum smelling and dark stained soil under the east end of Hangar A while digging for foundation. (Area 1 on the attached sketch) The material was left in a pile (pile 1) until sampling and testing could be done. Late that same day, some green stained soil and tar globs were found in area 2 at the west end of Hangar C as the drainage manhole was being installed.

- 8-16-99 Contractor found some more green stained soil in area 3 while excavating for another new manhole.
- 8-17-99 Contractor found some more green stained soil in area 5 just a foot down.

- 8-18-99 Olympus reported sampling results. Area 1 clean enough, but pile 1 had 1200 ppm heavy oil level (200 ppm is the threshold). Since the pile 1 was in the way and the contamination level would not readily clean up by aeration methods, it was decided to haul this out to TPS Technologies, Inc. in Tacoma for thermal treatment. The green stained soil was old paint and was found not to be a problem. But samples from area 2 and 3 had results of 790 ppm and 5600 ppm of heavy oil respectively on the side walls of the holes.

- 8-20-99 Olympus out to field screen for limits of contamination at areas 2 and 3. Contractor found more contamination while excavating at area 4. Olympus did field screening to determine limits of contamination at area 4 and took samples from areas 2,3 and 4 and piles 2B (the secondary material taken during field screening work done this day from areas 2 and 3), 4A and 4B for testing. More hauling of soil to TPS from pile 1 and pile 2A (the original material taken from areas 2 and 3 prior to the field screening work done this day).

- 8-23-99 Olympus reported the results for areas 2,3 and 4 and piles 2B (the secondary material taken during field screening work done this day from areas 2 and 3), 4A and 4B all were below the cleanup levels. As a precaution, the piles of material were not placed back on the t-hangar site, but were hauled up to the north end of the airport for disposal.

- 8-31-99 Contractor claimed to have found more contamination while over-excavating for the foundation at Hangar B at area 6. Olympus was called and they came out and did some field screening work and determined that there was no detectable contamination.
